LEE POND DAM

MA 00891

PHASE I INSPECTION REPORT  
NATIONAL DAM INSPECTION PROGRAM

JULY 1981

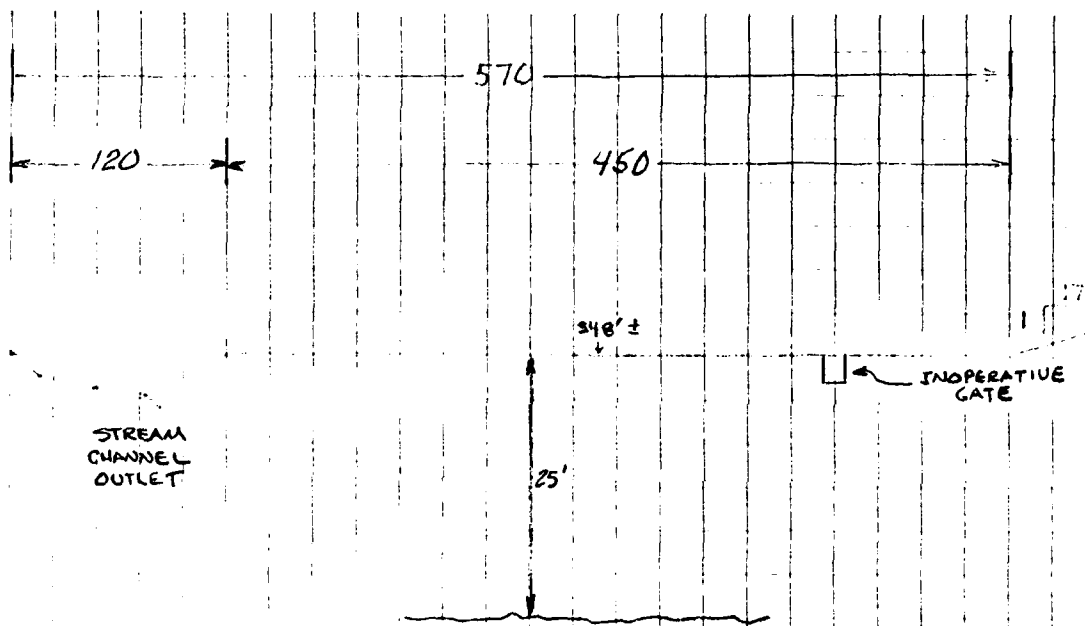
Figure 1

The gate on the right side of the dam (looking u/s - Figure 1) controls flow through a sluiceway near an abandoned mill building on the site. At present, this gate is inoperative and outflow now passes over the left side of the dam in a natural stream channel outlet. This natural stream channel outlet is now the main outlet for Lee Pond.
